#### Photographs: SBS BUILDING

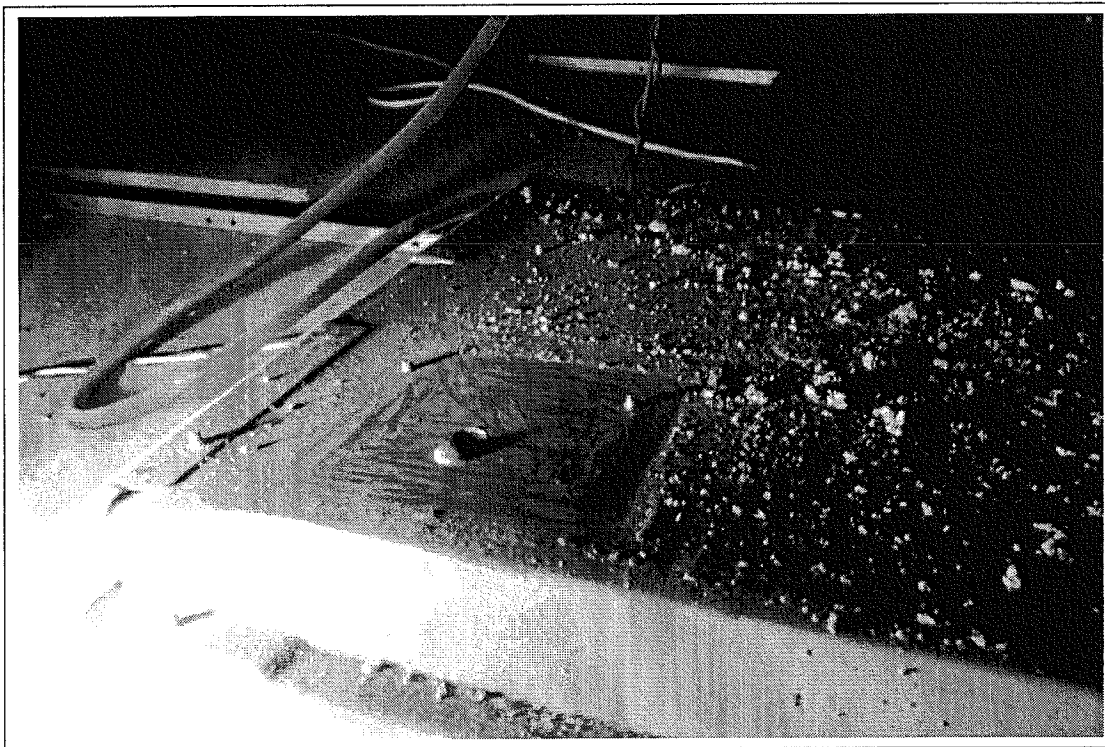
matrix and color) made at the time of dust collection confirmed that the dust and debris collected in the samples were from delaminated/dislodged fireproofing applied directly above the vacuumed surface. Analysis of the dust samples indicates extreme contamination based on asbestos concentrations ranging from approximately 1.65 billion to 40.5 billion asbestos fibers per square foot. Refer to table below:

Photo 11. ground floor meeting rm – top of fluorescent light fixture after dust sampling (sample # 1)

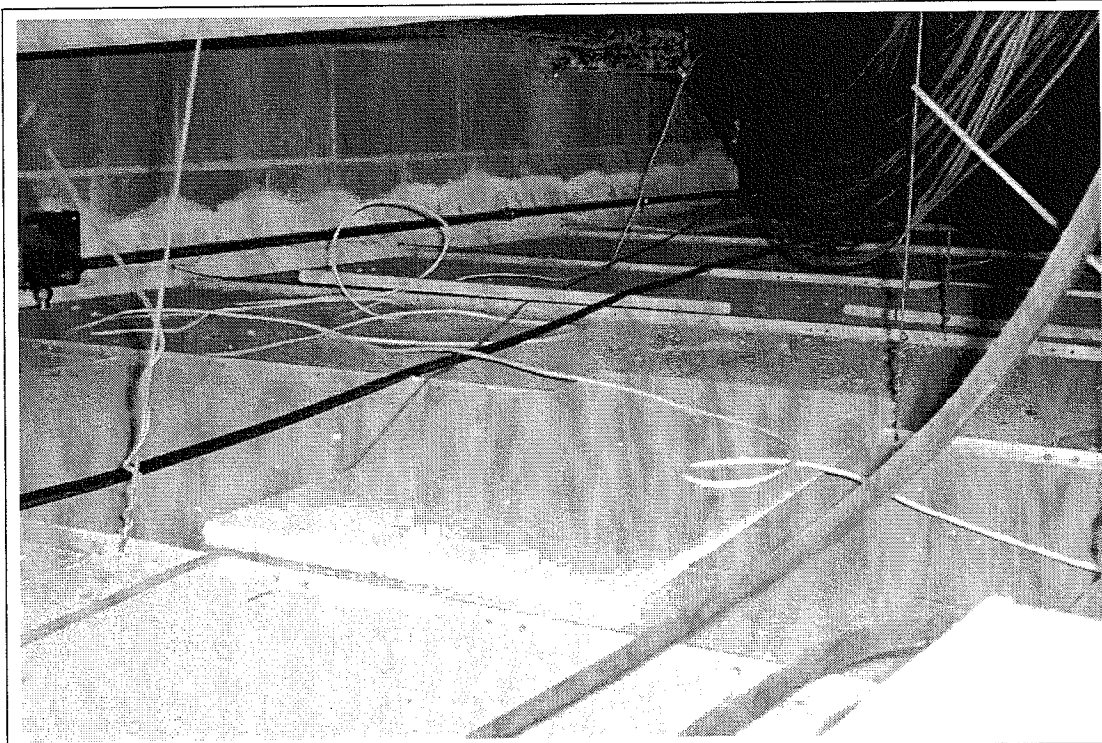
Photo 12. ground floor meeting rm – view of delaminated fireproofing on top of suspended ceiling

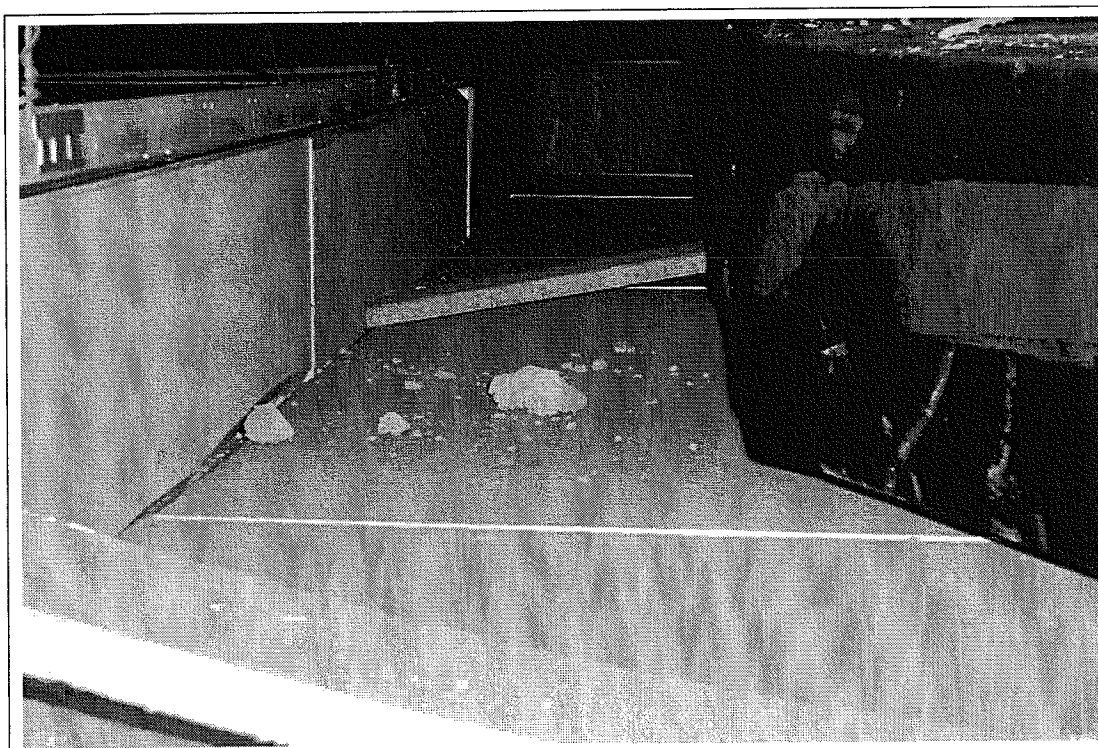
Photo 13. B floor west mechanical rm – large chunks of delaminated fireproofing above ceiling

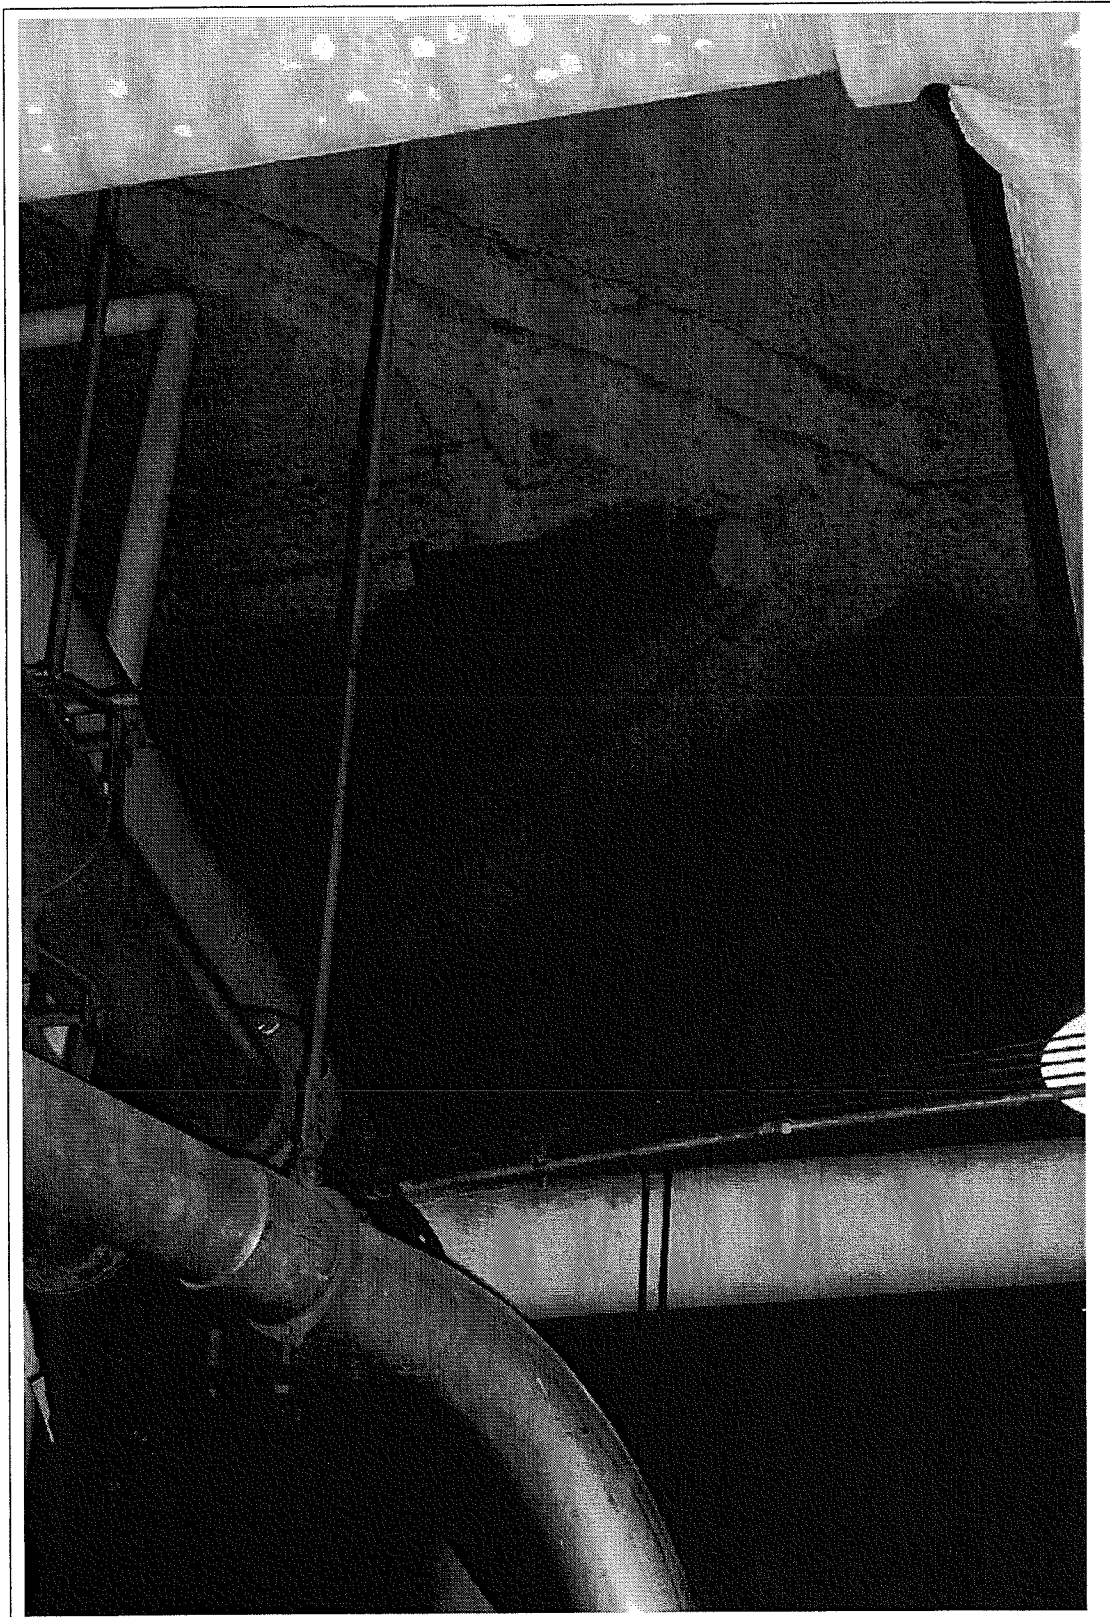
Photo 14. B floor east mechanical rm – view of delaminated fireproofing off steel I-beam

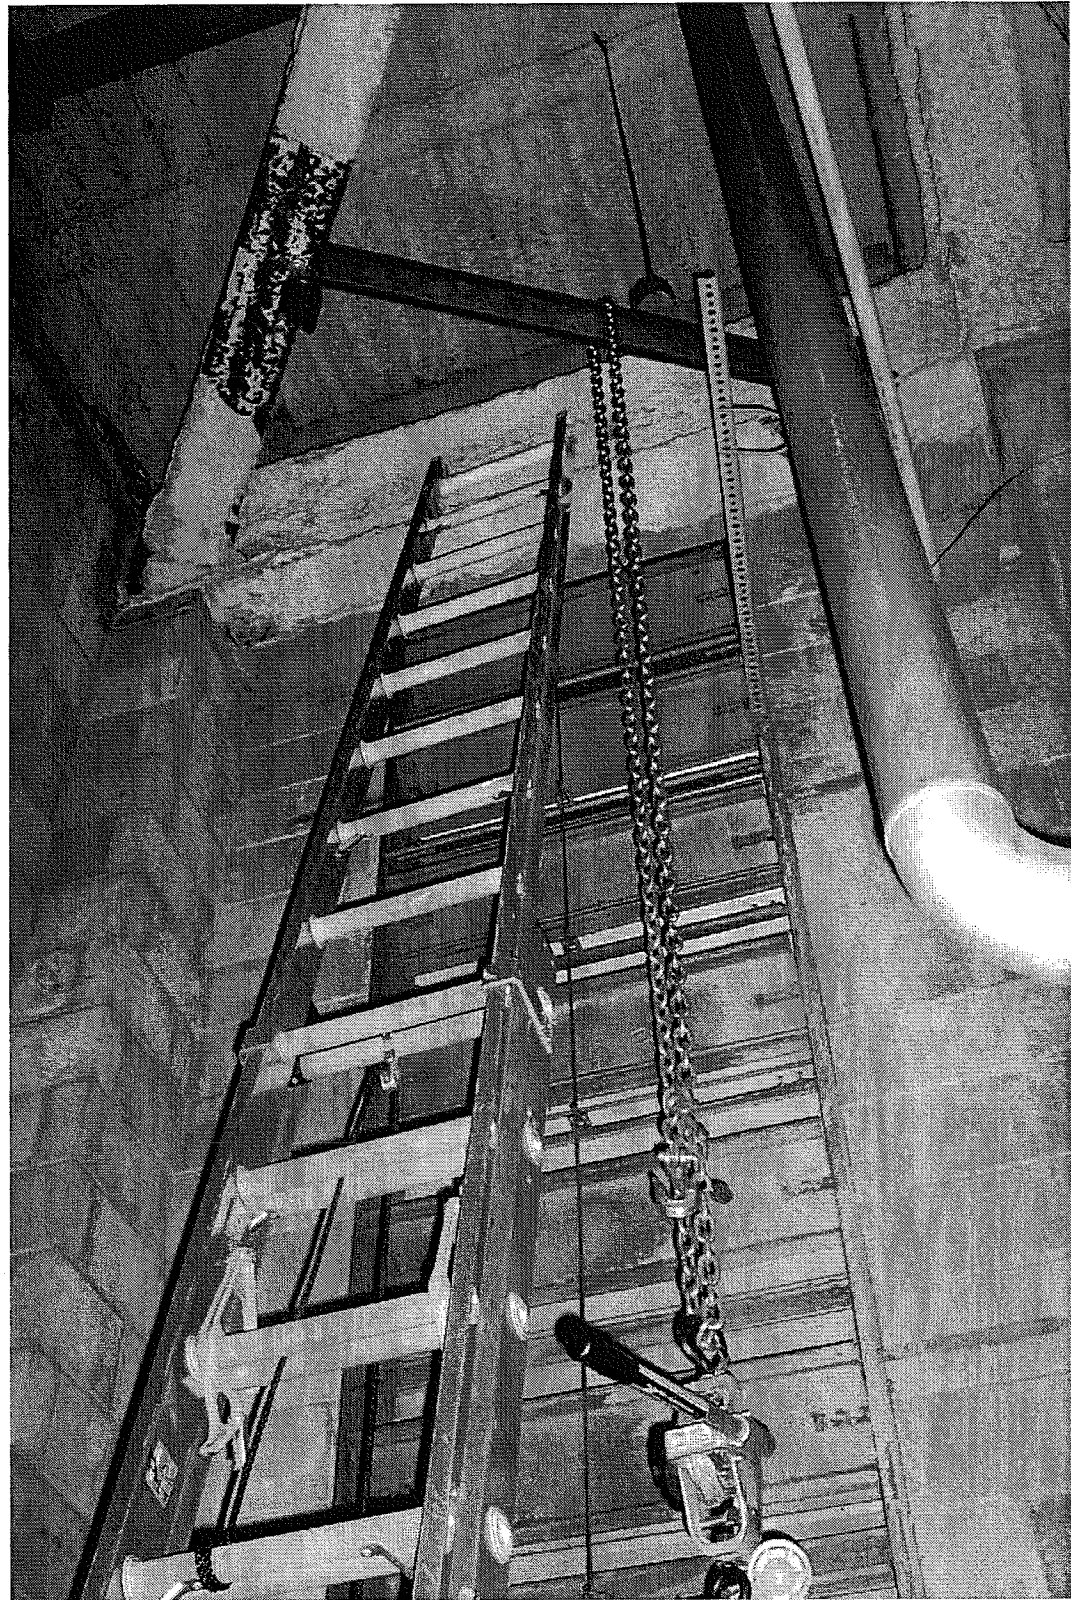
Photo 15. B floor east mechanical rm – view of ladder above breaker box
